USAAMRDL-TR-76-8

HIGH-SURVIVABLE TRANSMISSION SYSTEM

Bell Helicopter Company
P. O. Box 482
Fort Worth, Tex. 76101

Final Report for Period January 1974 - August 1975

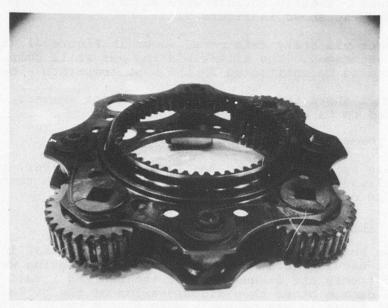
Figure 70. Lower planetary assembly following 4.0-hour emergency lubrication run.

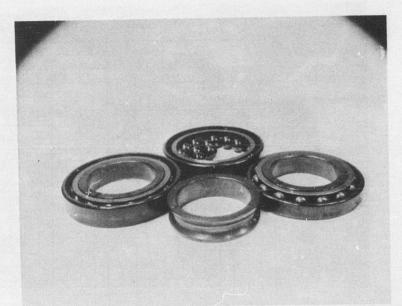
The balls of the triplex bearing were discolored, but otherwise the bearing appeared to be unharmed, as can be seen in Figure 75. The inner and outer races and the silver-plated steel cages looked good.

Figure 75. Main input triplex bearing following 4.0-hour emergency lubrication run.
